***2017 ASPECT Preliminary Report
Arkema Plant Response, Crosby, TX
&
Rapids Needs Assessment***

***September 1, 2017
0500 hrs to 1800 hrs***

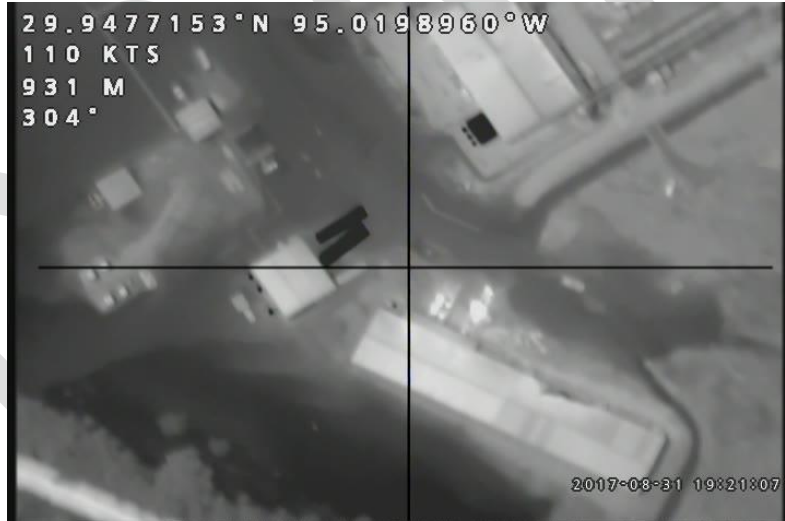
Figure 1: Infrared Image of two refrigerated containers at the Arkmen Facility on 31 August 2017

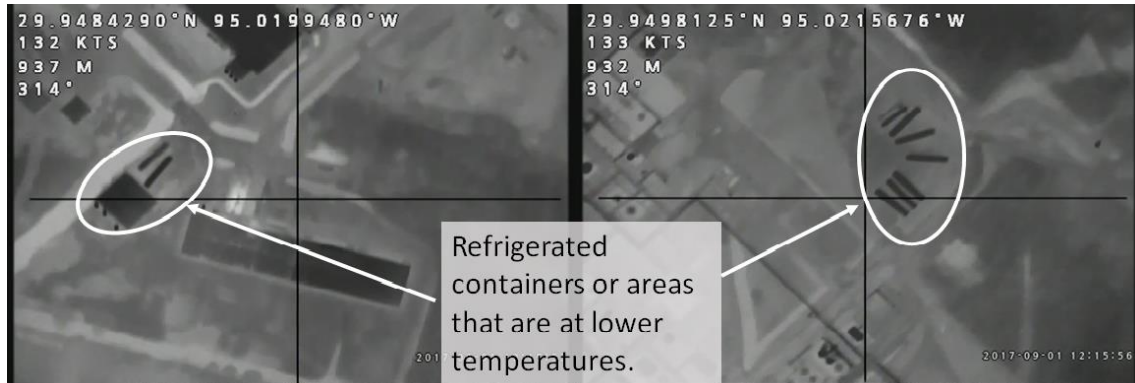
0720 hrs: ASPECT made numerous passes over the facility and there were no significant chemical detections. The crew reported that the IR video showed that the trailers are cool. See Figure 2.

Figure 2: Infrared images obtained from an infrared video (0615 hrs CST) clearly show that the containers are being cooled (black colors) at the Arkema facility.

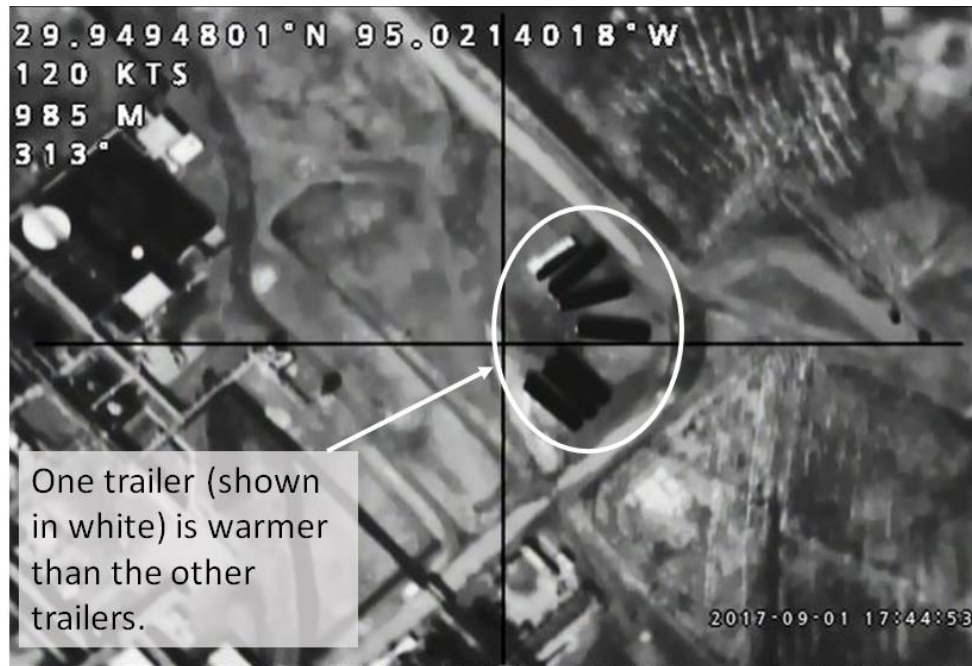
1240 hrs: ASPECT made numerous passes over the facility and there were several detections about 50 m downwind from the facility (wind direction was coming from 350 degrees with wind speeds less than 2 m/s) showing weak (e.g., slightly above the 5.3 ppm detection limit) signatures consistent with peroxide. Figure 4 is an image from the infrared video which indicates that the northernmost trailer looks warmer than the surrounding trailers. Figure 5 is an image of an oblique photo taken on 30 August of the trailers shown in Figure 4.

Figure 4: Image taken from the infrared video showing that one trailer looks warmer (e.g., colored white) than the surrounding trailers. The time stamp is UTC time; local time is 6 hours behind (1144 hrs CST).

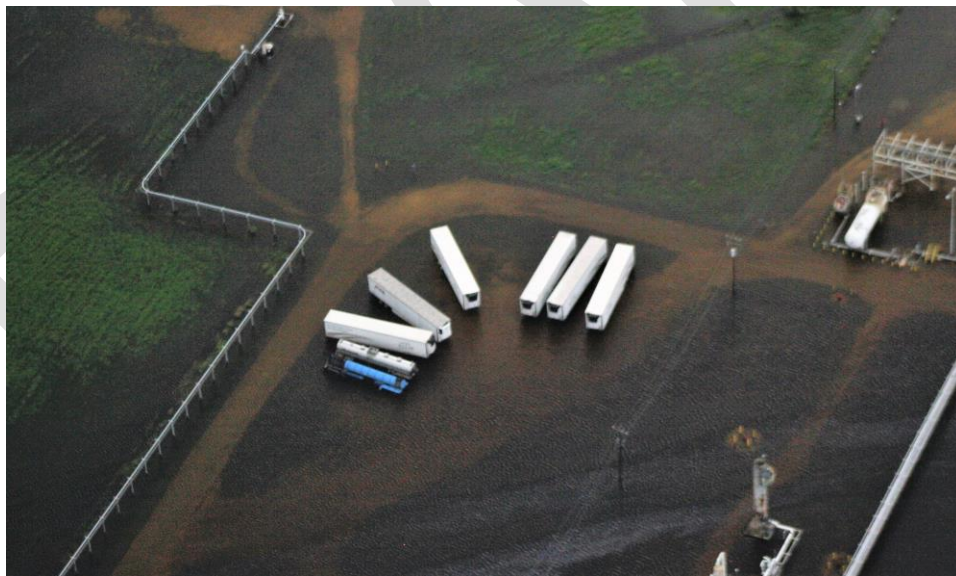
Figure 5: Oblique photo taken on 30 August 2017 of the trailers shown in Figure 4.

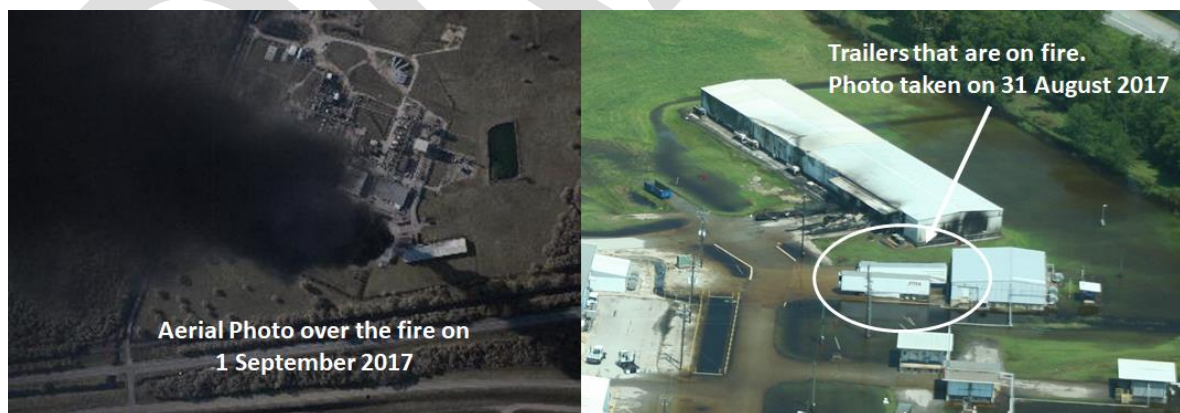
1710 hrs: ASPECT was airborne and arrived on site by 1725 hrs. Initial reports from the crew reported a yellow plume rising to 3,000 ft AGL. The crew increased altitude to 4,000 ft AGL to take aerial and oblique photos as well as conducting chemical sweeps over the site. Figure 6 shows the plume coming from the trailer(s) which were on fire. The image to right is an oblique image taken from the aircraft on 31 August 2017.

Figure 6: Thumbnail image (left, very low resolution) taken from the aircraft during the response. Oblique image showing the trailers that eventually caught fire.

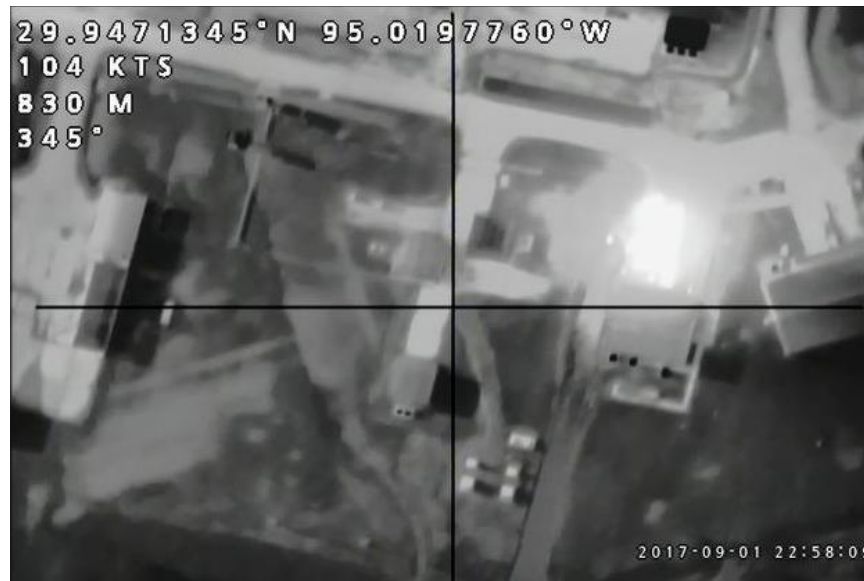
1800 hrs: Figures 7 & 8 show intense heat where the trailers are on fire. Figure 7 is an image that was pulled from the aircraft while in flight. Figure 8 was obtained after the aircraft landed

Figure 7: Infrared image obtained from an infrared video taken during the fire.

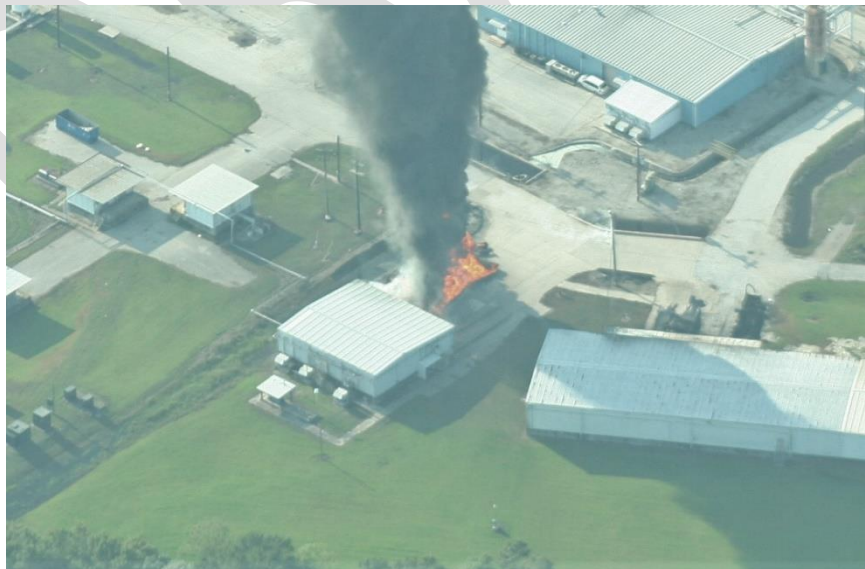
Figure 8: Oblique image of the trailers on fire.

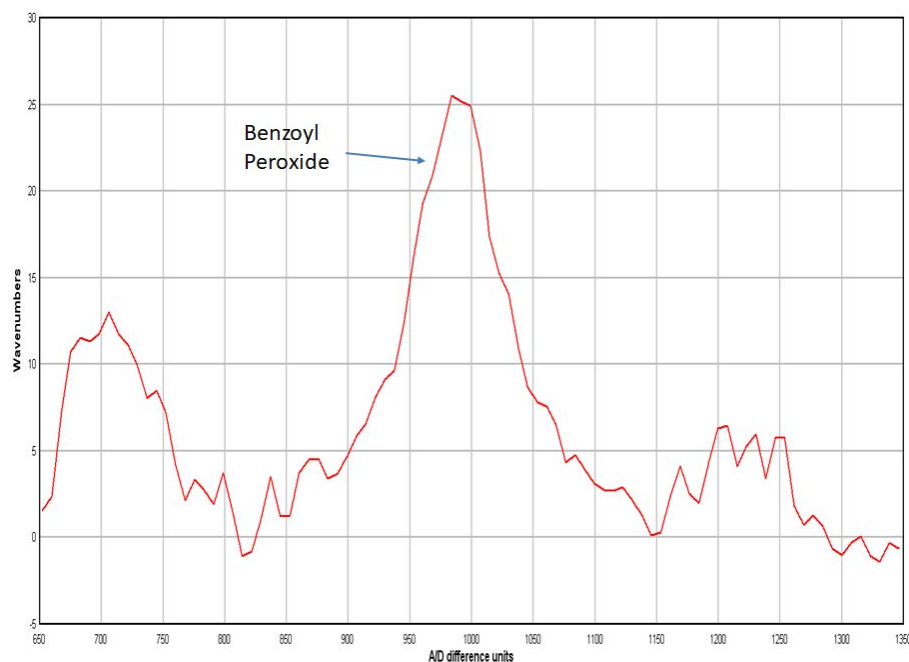
1815 hrs: The aircraft remained on station, making 19 passes over the fire to continue monitoring and collect photos. Figure 8 illustrates the spectral characteristics of a typical hot fire. The primary constituents observed in this spectra are ozone, benzoyl peroxide, trace quantities of hot carbon dioxide and possibly small amounts of 1-butene (combustion products).

Figure 9: Image of the FTIR spectra collected over the fire. Primary constituents observed in this spectra are ozone, benzoyl peroxide, trace quantities of hot carbon dioxide and possibly small amounts of 1-butene (combustion products).
